### CASE STUDY HANDOUT FOR CILA WASTE TALK 27 NOVEMBER 2014

## The premises and plant

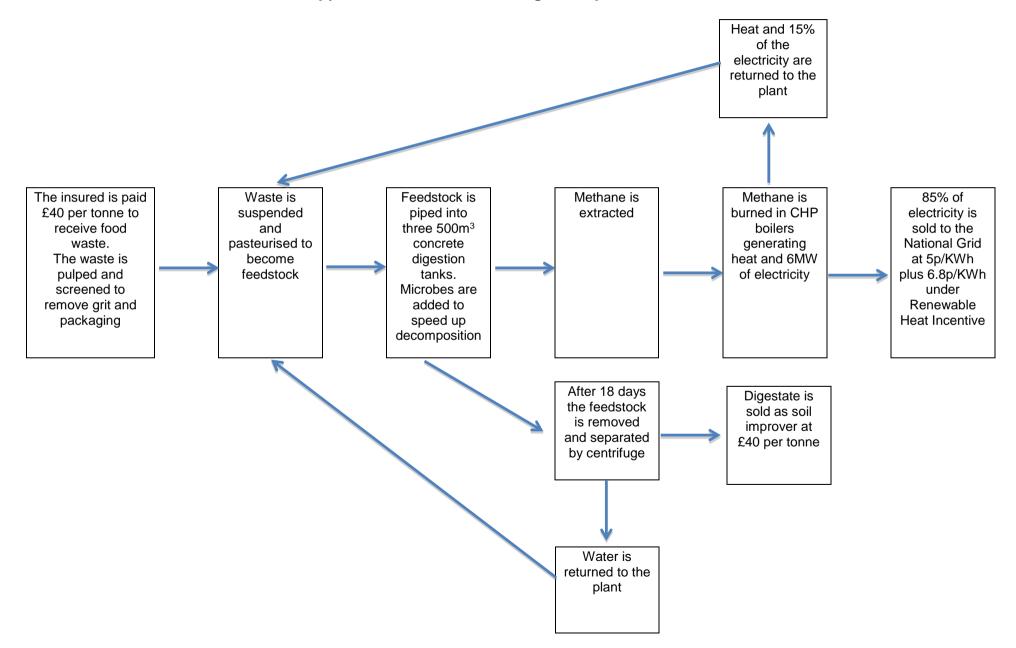
# Appendix A: The anaerobic digestion process

- The insured receives local authority food waste at its anaerobic digestion plant in northern England. The plant is a proprietary design from a company based in continental Europe which was installed and commissioned by a UK contractor in January 2013.
- 2. The process is illustrated by the diagram attached at Appendix A.
